Clive Park Actions

Status: **Draft**
 Prepared by: S. Hall, M. Van Vugt
 Drawn by: H Suba
 Date printed: 30/11/2016
 Approximate Scale: 1:1500

Draft Clive Park Bushland Reserve Action Plan

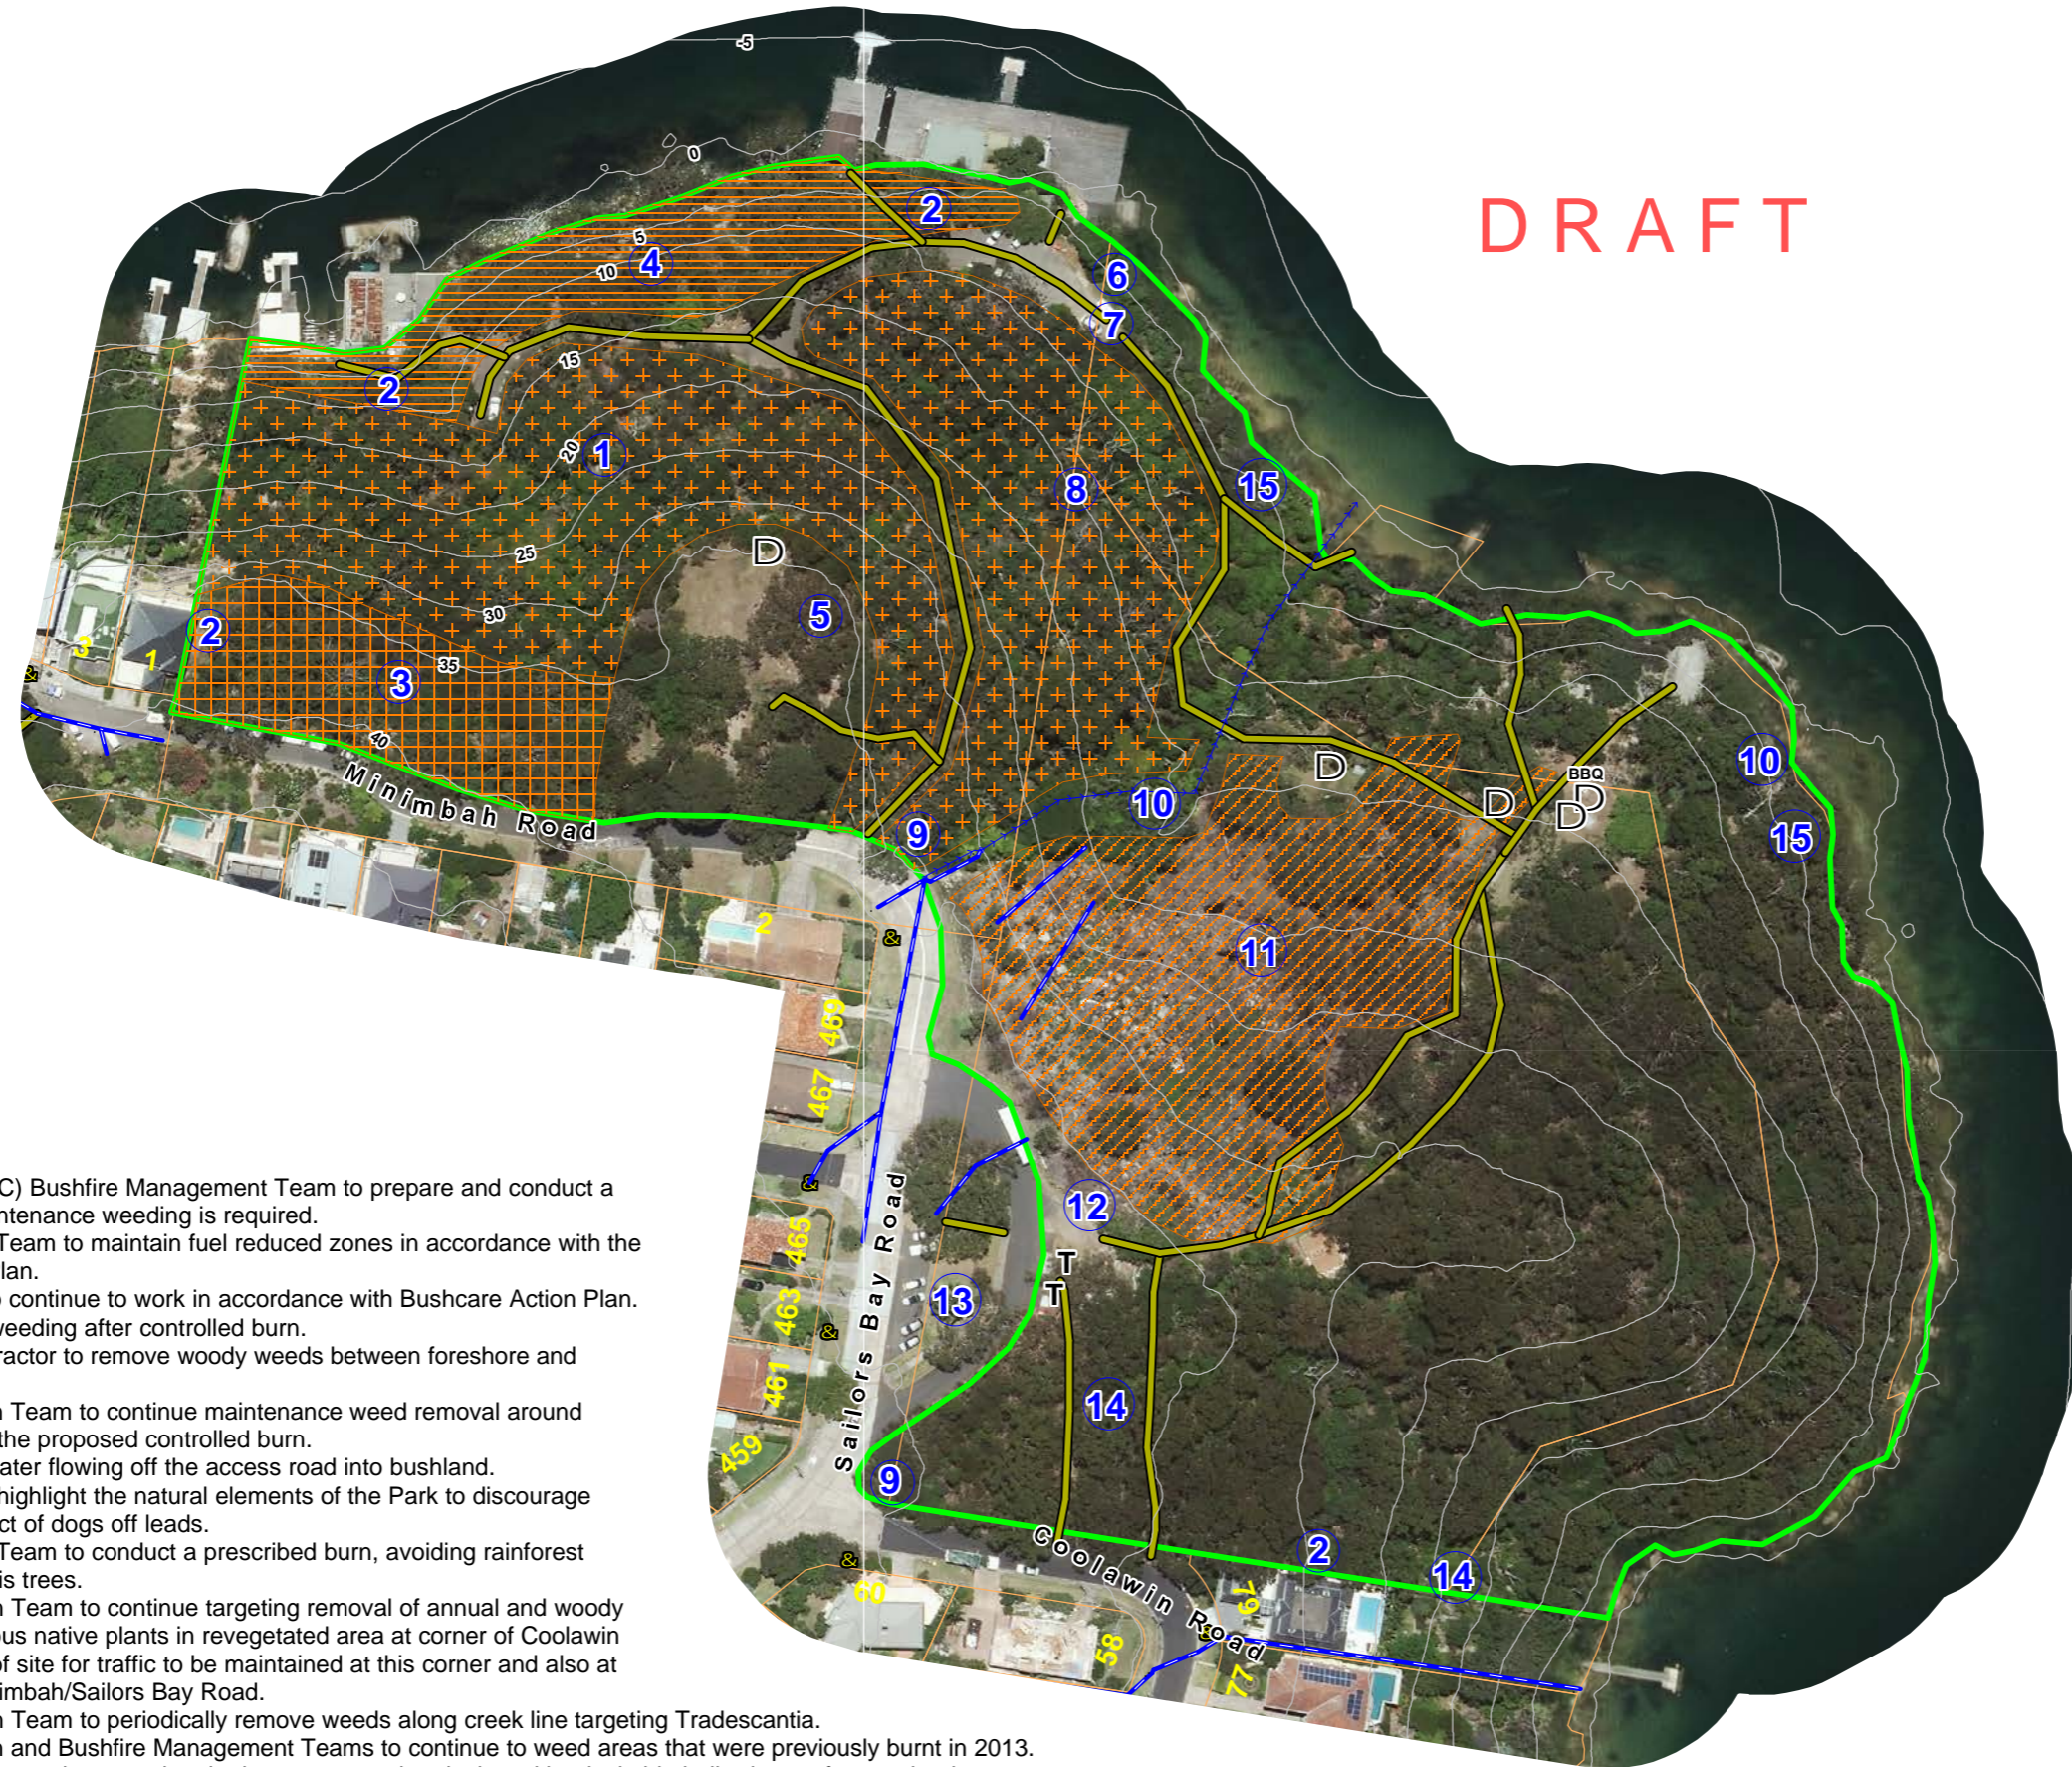
1. Willoughby City Council (WCC) Bushfire Management Team to prepare and conduct a controlled burn. Post fire maintenance weeding is required.
2. WCC Bushfire Management Team to maintain fuel reduced zones in accordance with the Bushfire Risk Management Plan.

3. Clive Park Bushcare group to continue to work in accordance with Bushcare Action Plan. Group to complete post fire weeding after controlled burn.
4. Bushland Regeneration Contractor to remove woody weeds between foreshore and access road.

5. WCC Bushland Regeneration Team to continue maintenance weed removal around picnic area prior to and after the proposed controlled burn.
6. Monitor the impact of stormwater flowing off the access road into bushland.

7. Install an interpretive sign to highlight the natural elements of the Park to discourage illegal dumping and the impact of dogs off leads.
8. WCC Bushfire Management Team to conduct a prescribed burn, avoiding rainforest vegetation and mature Callitris trees.

9. WCC Bushland Regeneration Team to continue targeting removal of annual and woody weeds and also non-indigenous native plants in revegetated area at corner of Coolawin and Sailors Bay Road. Line of site for traffic to be maintained at this corner and also at Park exit at the corner of Minimbah/Sailors Bay Road.

10. WCC Bushland Regeneration Team to periodically remove weeds along creek line targeting Tradescantia.
11. WCC Bushland Regeneration and Bushfire Management Teams to continue to weed areas that were previously burnt in 2013.

12. Upgrade amenity of Park entrance by removing the boom gate and replacing with a lockable bollard, resurface path, plant indigenous shrubs and groundcovers and install an interpretive sign highlighting natural features and the impact of dogs off leads.

13. Remove Strelitzia in car park and replace with an indigenous tree (Eucalyptus haemastoma or Angophora costata).
14. WCC Bushland Regeneration Teams to continue maintenance weed removal targeting Passionfruit Vine, Seaside Daisy, herbaceous and annual weeds.

15. WCC Bushland Regeneration Team to complete annual maintenance weed removal sweep along foreshore targeting Asparagus Fern.
16. WCC Bushland Regeneration Teams to regularly monitor Aboriginal archaeological sites within the Park. Remove rubbish and report vandalism.

17. Continue with feral animal control program within the reserve.
18. Supplement arboreal and terrestrial habitat with nest boxes, rocks and logs.
